## Case Study:

# Using EnergyWitness™ to Find Root Cause of a BAS Alarm

(First in a series of diagnostic case studies)

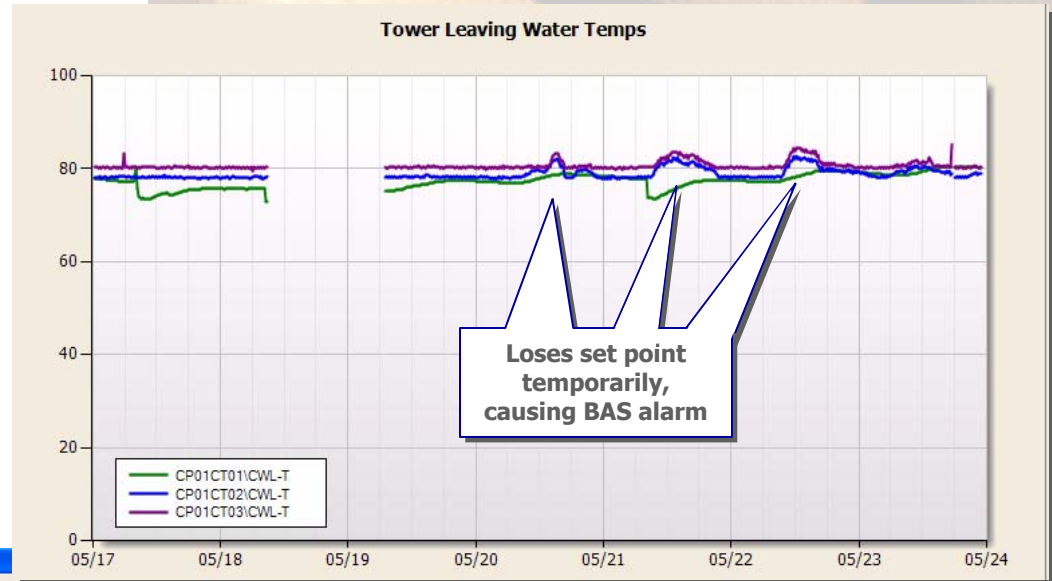
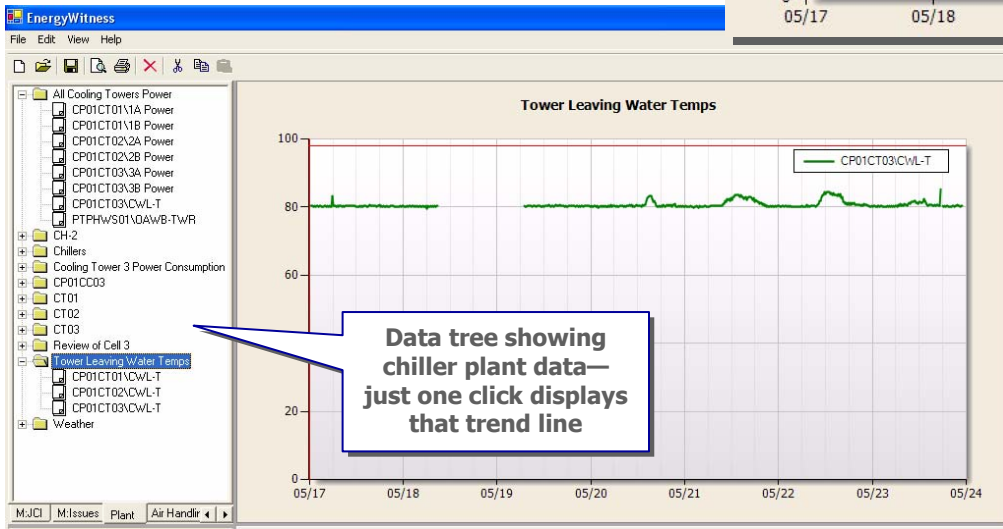
First we looked at the water temperatures leaving the cooling towers for each cell.

Tower 3 had the most difficult time achieving set point (80°F).

We confirmed that set point was not consistently maintained, and we can show why (and when) the alarm was intermittent.

(Note: the trend line gaps are due to networking issues with the BAS.)

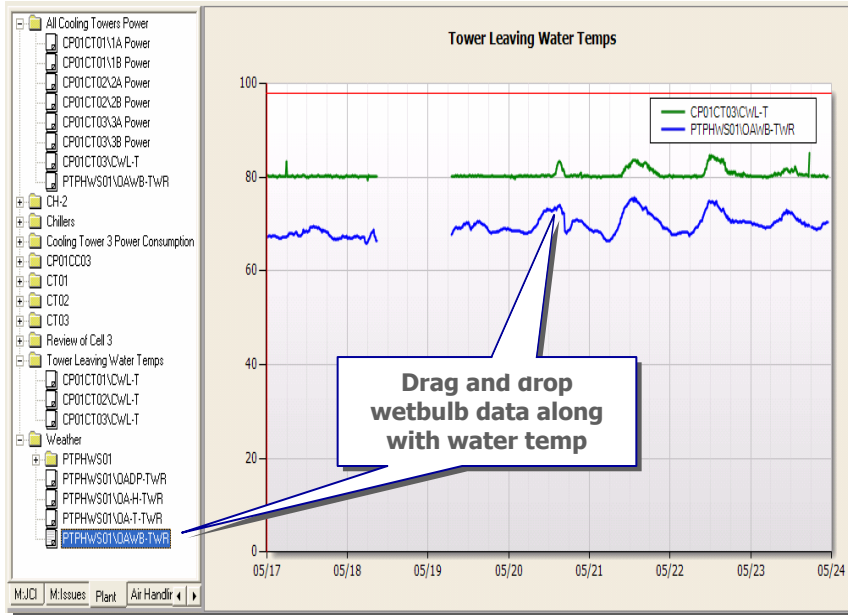
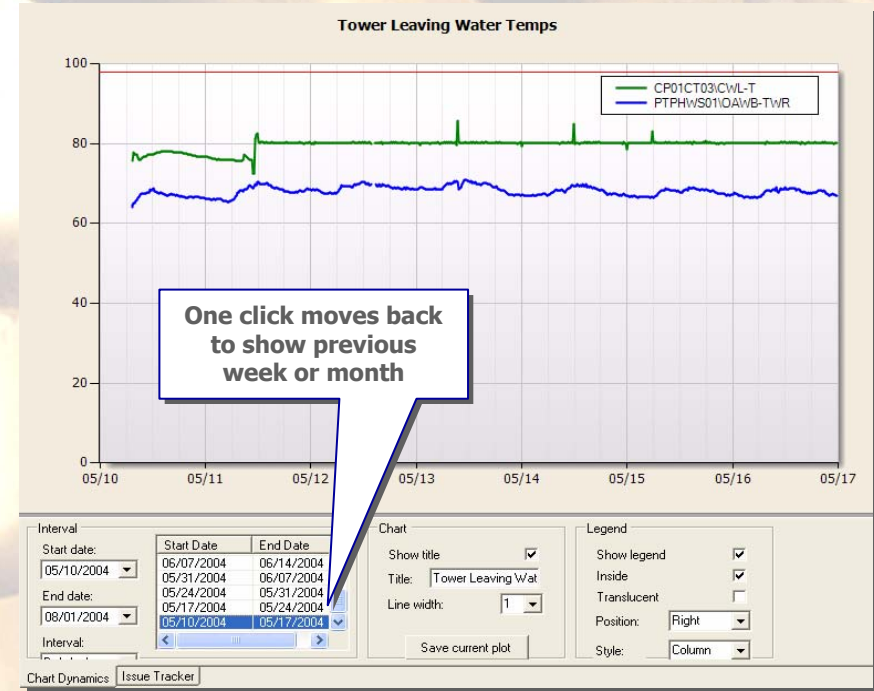
For the next step we checked the weather conditions and added (by drag and drop) the tower wetbulb temperature into the chart.

Going back in time for a week (takes just 2 seconds with EnergyWitness) we can now conclude that when the wetbulb temperature exceeds 73.4°F the tower cannot maintain set point.

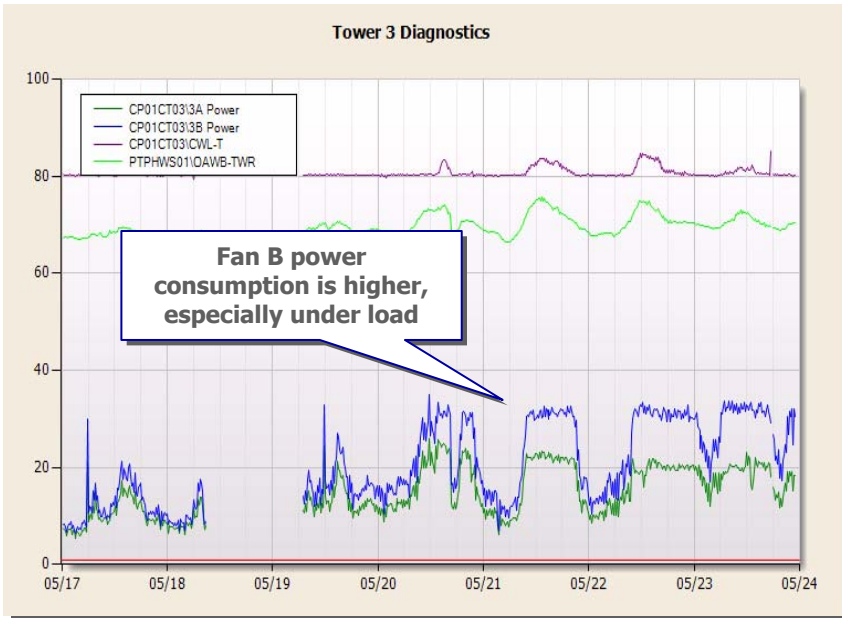
We looked at how much power the two cooling tower fans were using, and immediately noticed that two identical fans drew very different amounts of power. Notice that the difference is much greater when a heavier load exists, corresponding to the increases in wetbulb temperature.

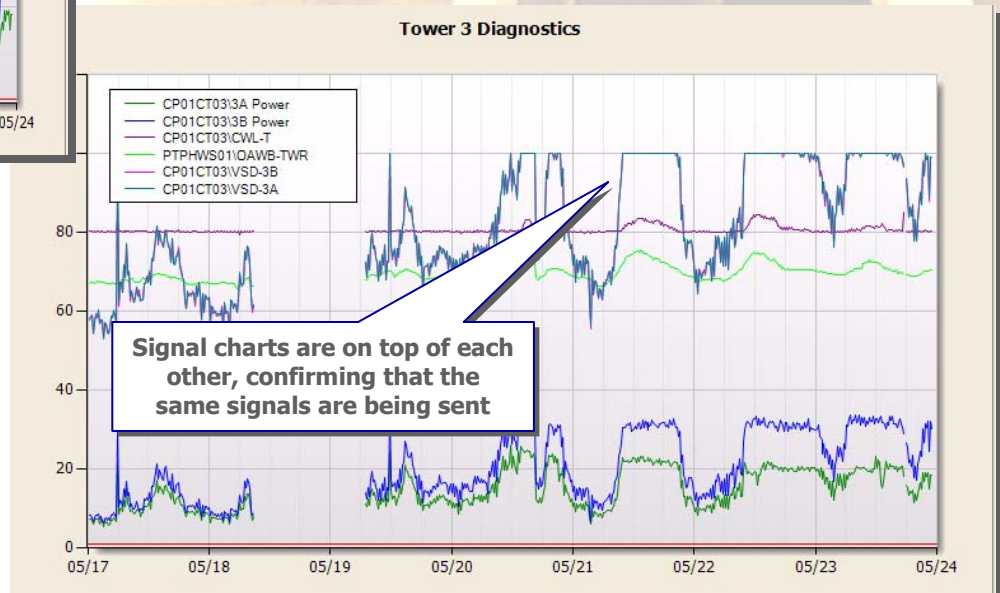
We can't confirm that the fans are running at the same speed because no BAS point exists to record that data. But we can look at the signals sent to each variable speed drive (VSD)—just drop them onto the chart.

Both fans received the same signal but responded very differently. How long has this been going on?

- We concluded that the problem was likely a fan belt slipping because it was a variable speed drive.
- The fan belt was checked and found to be loose.
- It was tightened and now we can look at the affects of the belt tightening.

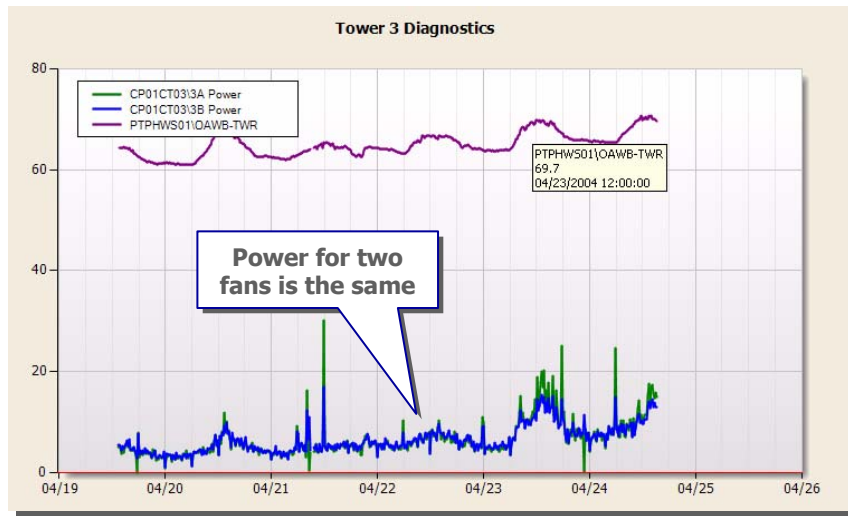
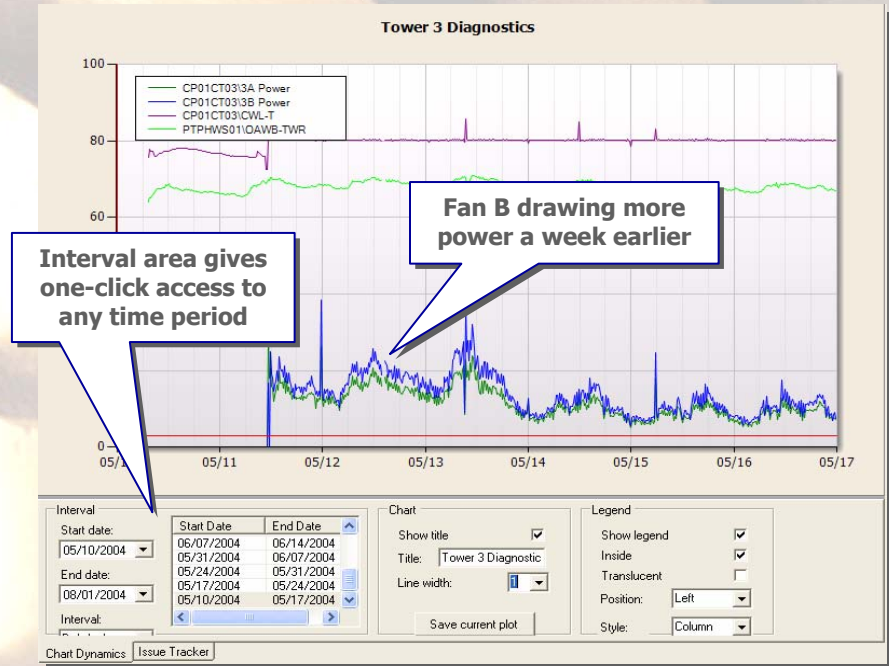
A quick click on the previous week in the time interval area shows that fan B has been using more power for a while.

Looking back several weeks we can see both fans in near unison. However, the wetbulb temperature never exceeds 70°F this early in the year.

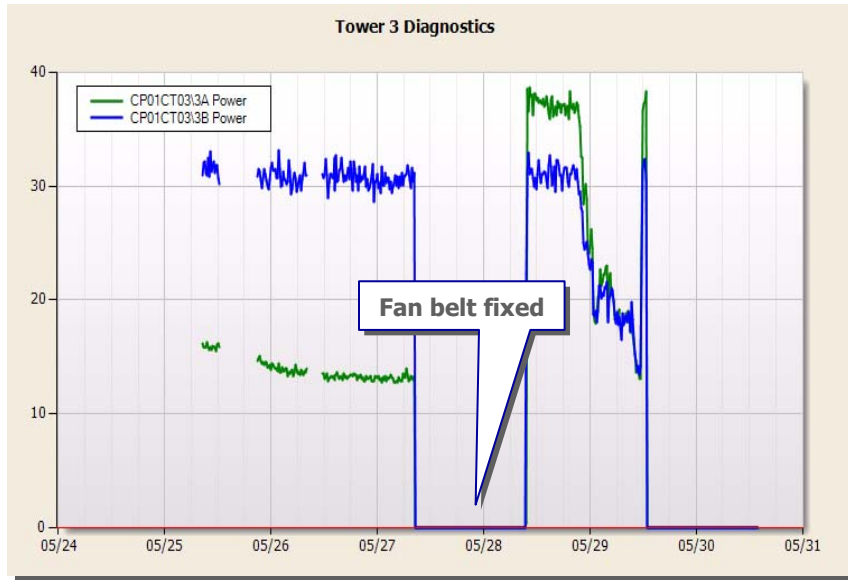
The tower cell was taken down while the fan belt was tightened.

We see immediately when it comes back on line that fan A now uses more power than fan B (actually there are more problems with this tower than just the belts) but we can't go into that now.

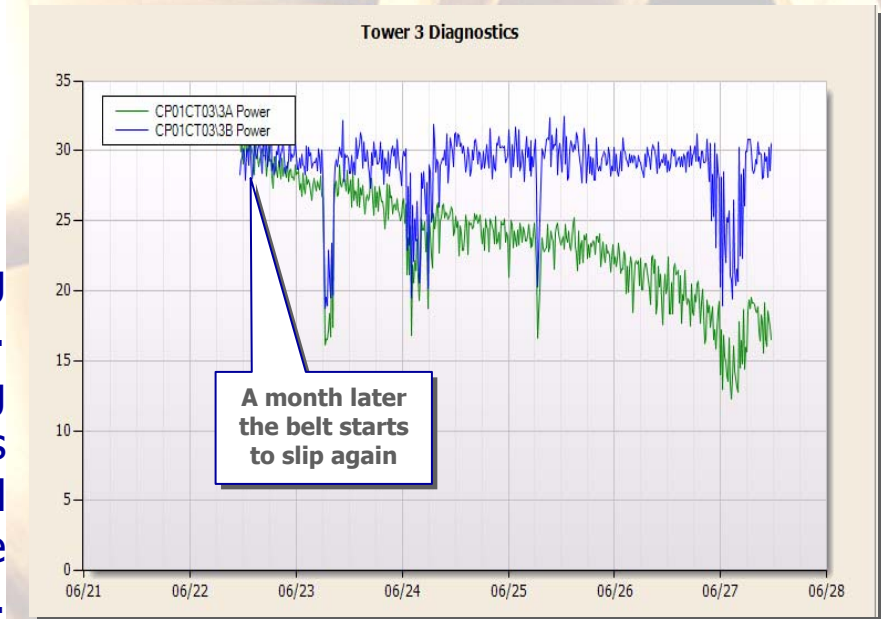
With EnergyWitness we can monitor ongoing operations in few seconds.

In this case we discovered the belt slipping again just a month later. Ultimately it needs more than tightening, it needs replacing—and now they have the data to prove the expenditure is warranted.
